Manhole Inspection Summary

Manhole # S45K__020MH

Insp Date: **8/19/09 9:27 AM**

Location Address: **1816 Aliceanna St**

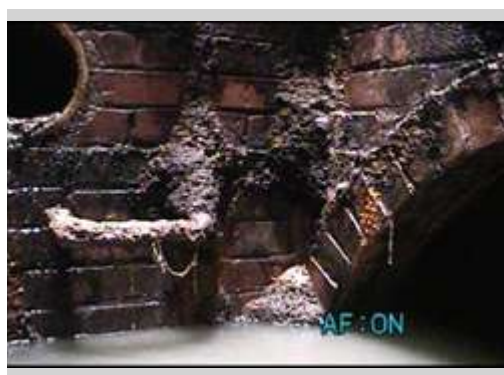
Defect 5

Infiltration: ☐ None ☐ Joint ☐ Cracks ☐ Mortar ☐ Roots ☒ **Wall**

mud depoists at barrel wall

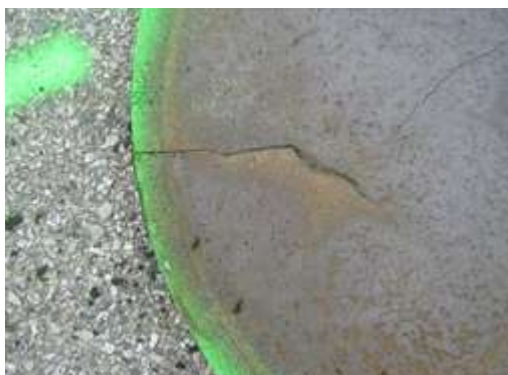
Defect 1

Condition: **Cracked**

crack in MH Lid

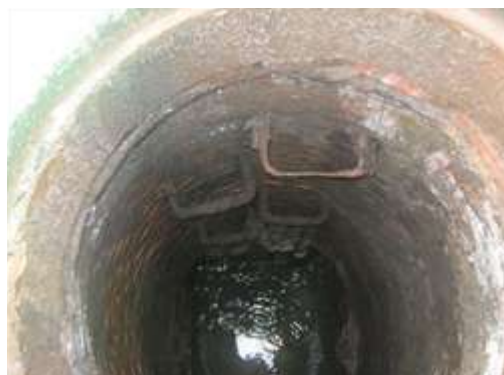
Defect 4

Count: **9** Missing: **2** ☒ **Corroded**

☒ **Evidence Of Surcharge** Depth: **8** (ft.) ☐ Active Surcharge Present

missing/corroded steps; surcharge evidence

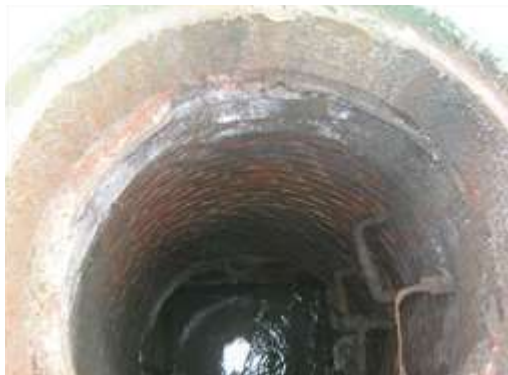
Defect 2

Condition: ☐ Sound ☐ Cracked ☐ Root Intrusion ☐ Loose Brick ☒ **Deteriorated**

deteriorated chimney

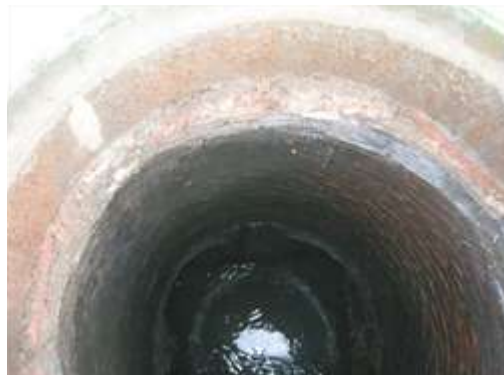
Defect 3

Offset: **1.5** (in.)

frame offset
